NASA
Technical Memorandum 106901

Transmission Diagnostic Research at NASA Lewis Research Center

Prepared for the
Second International Conference on Gearbox Noise, Vibration, and Diagnostics
sponsored by the Institution of Mechanical Engineers
London, England, November 16-17, 1995

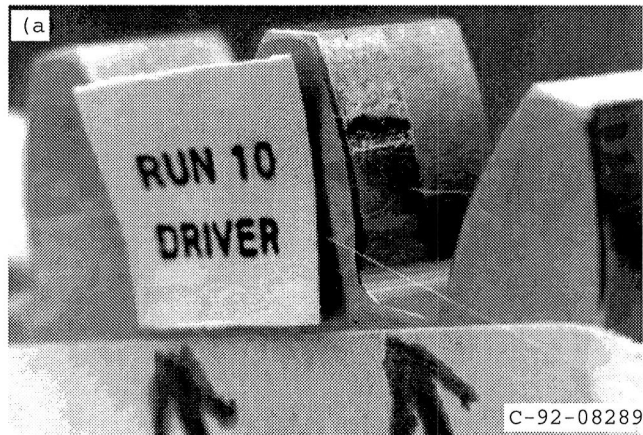
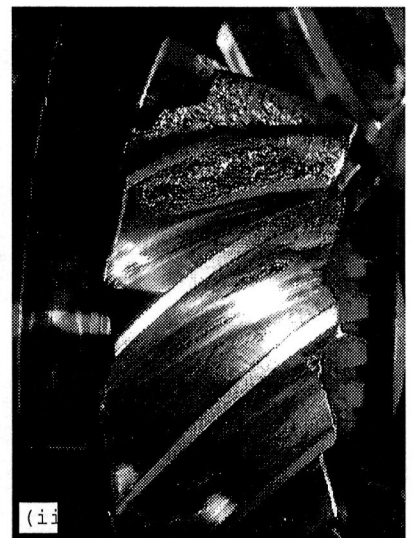
Figure 1.—(a) Sample of pitting damage on spur gears (spur gear test #2). (b) Spiral pinion damage during spiral bevel fatigue test #1. (i) At $t = 5.5$ hr. (ii) At $t = 12.0$ hr. (iii) At $t = 17.79$ tooth fracture damage on face gears (face gear test #5).

There are a total of four spur gear fatigue test rigs that have been operational since 1972. The primary purpose of these rigs is to study the effects of gear materials, gear surface treatments, and lubrication types on the surface fatigue strength of aircraft quality gears. The test gears are run offset to maximize contact stress while maintaining an acceptable bending stress. Vibration data from an accelerometer mounted on a bearing end plate was captured on a personal computer with an analog to digital conversion board. The test gears are standard spur gears having 28 teeth and a pitch diameter of 88.9 mm (3.50 in.). The gears were loaded to 74.6 Nm (660 in-lb) at an operating speed of 10 000 rpm. Figure 1a shows a sample of the heavy pitting damage found on a gear tooth surface at the end of a test on the spur gear rig. A total of five tests on this rig were monitored and recorded for gear diagnostics research. The primary mode of failure on all five tests was surface pitting, ranging from light and moderate pitting on a single tooth to heavy pitting and spalling over a majority of the gear tooth surface on a number of teeth.

rig for diagnostic studies is extremely relevant, since spiral bevel gears are used extensively in helicopter transmissions to transfer power between intersecting shafts. Vibration data from an accelerometer mounted on the pinion shaft bearing housing was captured using a personal computer with an analog to digital conversion board. The 12-tooth test pinion, and 36-tooth gear have a 25.4 mm (1 inch) face width, and a 90 degree shaft angle. The pinion transmits 537 kW (720 Hp), at a nominal speed of 14 400 rpm. Two complete fatigue tests were recorded and documented on this rig. Figure 1b illustrates the damage on the pinion at three distinct times during the first fatigue test. As seen in figure 1b-i, a small pit was first seen on the pinion when the rig was shut down at 5.5 hours. The damage spread to cover more than 75% of the tooth at 12 hours, as seen in figure 1b-ii. At the end of the test, 17.79 hours into the run, the damage covered the majority of three adjacent teeth, with one tooth experiencing a partial tooth fracture, as seen in figure 1b-iii. The second fatigue test exhibited a similar failure pattern, with damage starting with a small pit on one tooth, growing to extensive pitting damage over five consecutive teeth on the pinion.

A spiral bevel rig, similar to the one described above, was also used to run face gear fatigue tests. The application of face gears to aircraft transmissions is part of an advanced rotorcraft transmission technology program. Face gears had never been tested at high speeds and high loads. The primary objectives of the face gear fatigue tests were to determine the load capacity and the primary failure mechanism for this type of gear. A standard 28 tooth spur gear drives the 107 tooth face gear at 19 107 rpm with 67.8 Nm (600 in-lb) of torque. The face gear/pinion mesh has an effective contact ratio of 2.1, meaning that at least two gear teeth are in contact at all times. Again, vibration data from an accelerometer mounted on the pinion shaft bearing housing was captured using a personal computer. A total of four face gear fatigue tests were monitored and recorded for gear diagnostics research. Tooth fracture and gear tooth surface pitting were the primary failure modes for all four tests. The damage ranged from pitting with partial tooth breakage on one test to severe pitting with complete tooth fracture of several teeth, as illustrated in figure 1c.
